LLL: UCRL-52533  
NASA: CR-159512

# HIGH-PERFORMANCE FIBER/ EPOXY COMPOSITE PRESSURE VESSELS

December 12, 1978

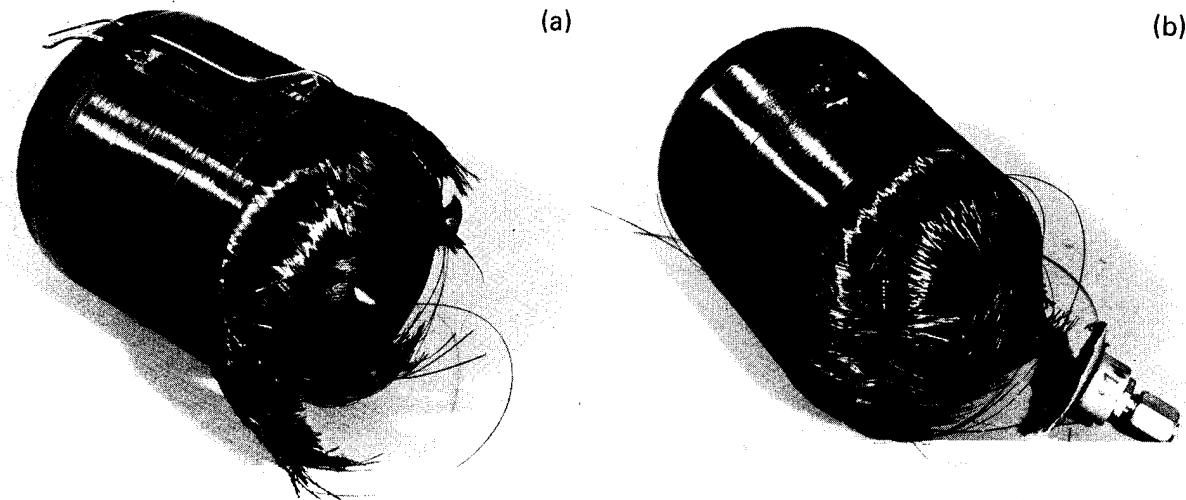
Fig. 12. Photograph of typical end failures during burst tests of titanium-lined (left) and aluminum-lined (right), Thorne Special graphite fiber/epoxy pressure vessels.

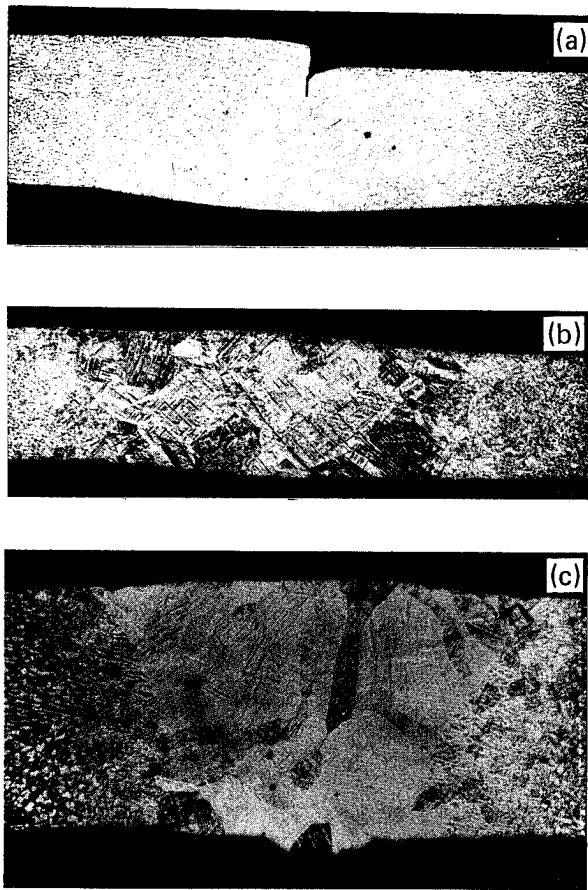
Because of the liner problems (stress concentrations and incomplete weld penetration), careful study of the fatigue data will be required to determine correctly the fatigue life of a "normal" vessel (see Fig. 17b). The one test vessel free from both liner problems

Fig. 17. Photomicrographs of electron-beam butt welds: (a) poor weld in a 0.25-mm-thick liner, (b) good weld in a 0.25-mm-thick liner, (c) good weld in a 0.51-mm-thick liner.

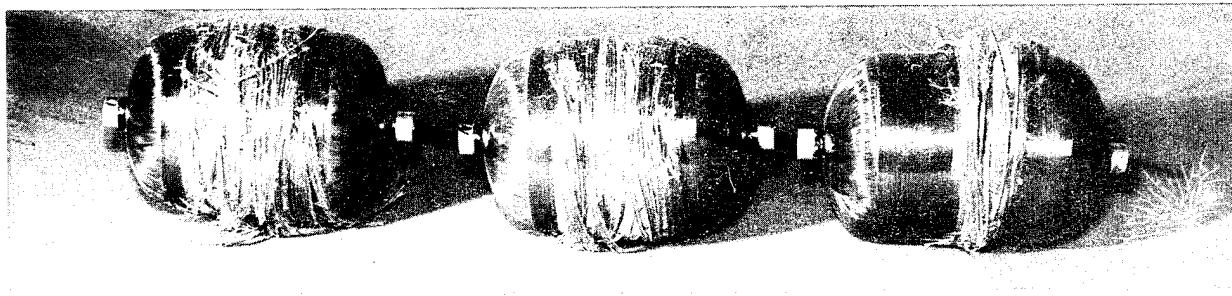
Fig. 23. Typical pressure vessel failures: from left to right, vessels made with epoxy systems 1, 4, and 7.

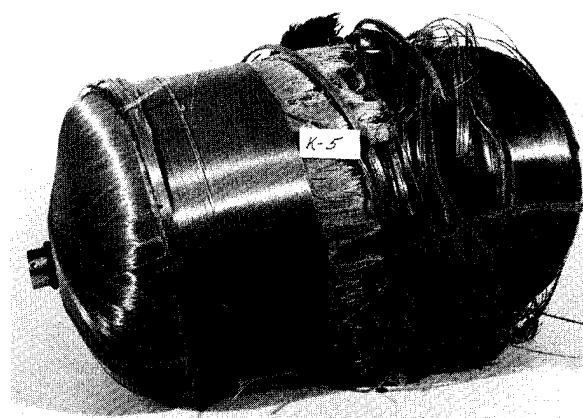
Fig. 38. Photograph of the hoop failure of the K-5, 20.3-cm-diameter pressure vessel.

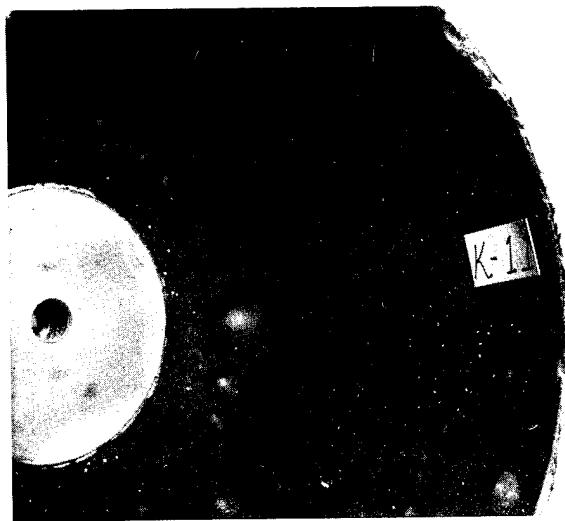
Fig. 41. Photograph of the interior of the K-11, 20.3-cm-diameter pressure vessel showing the pitted Parylene C liner.

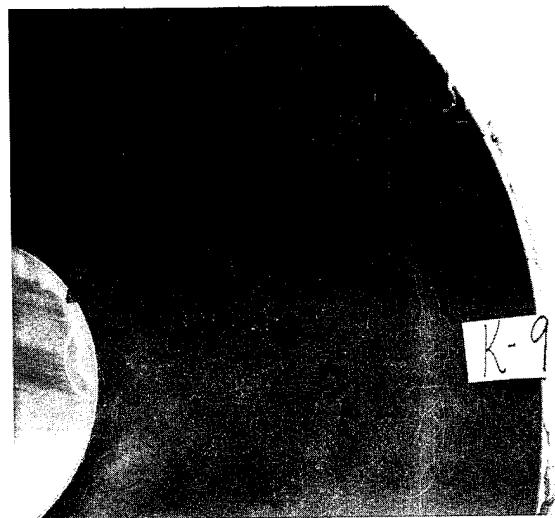
Fig. 42. Photograph of the interior of the K-9, 20.3-cm-diameter pressure vessel showing the cell-like structure of the Parylene C liner.

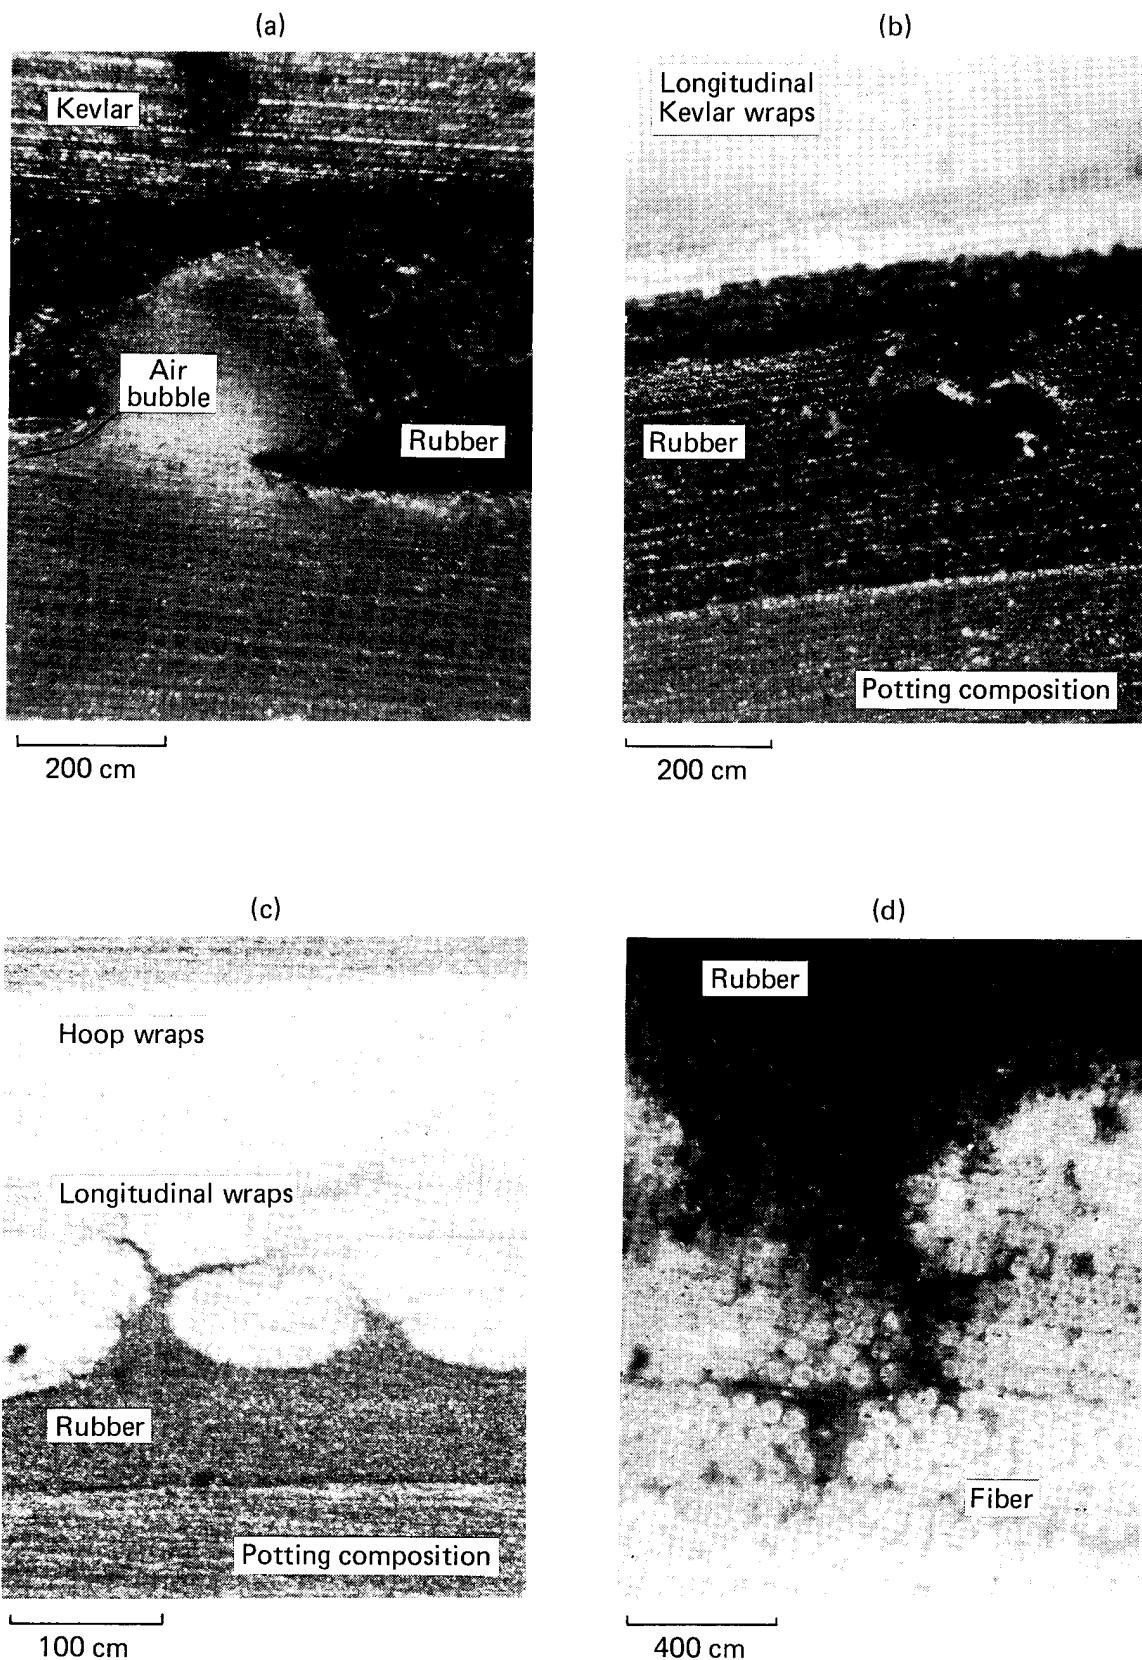
Fig. 43. Photomicrographs of four wall sections illustrating some of the problems with the liners: (a, b) 20.3-cm<sup>3</sup>-diameter vessels with voids, (c, d) 10.2-cm-diameter vessels with rubber migration.

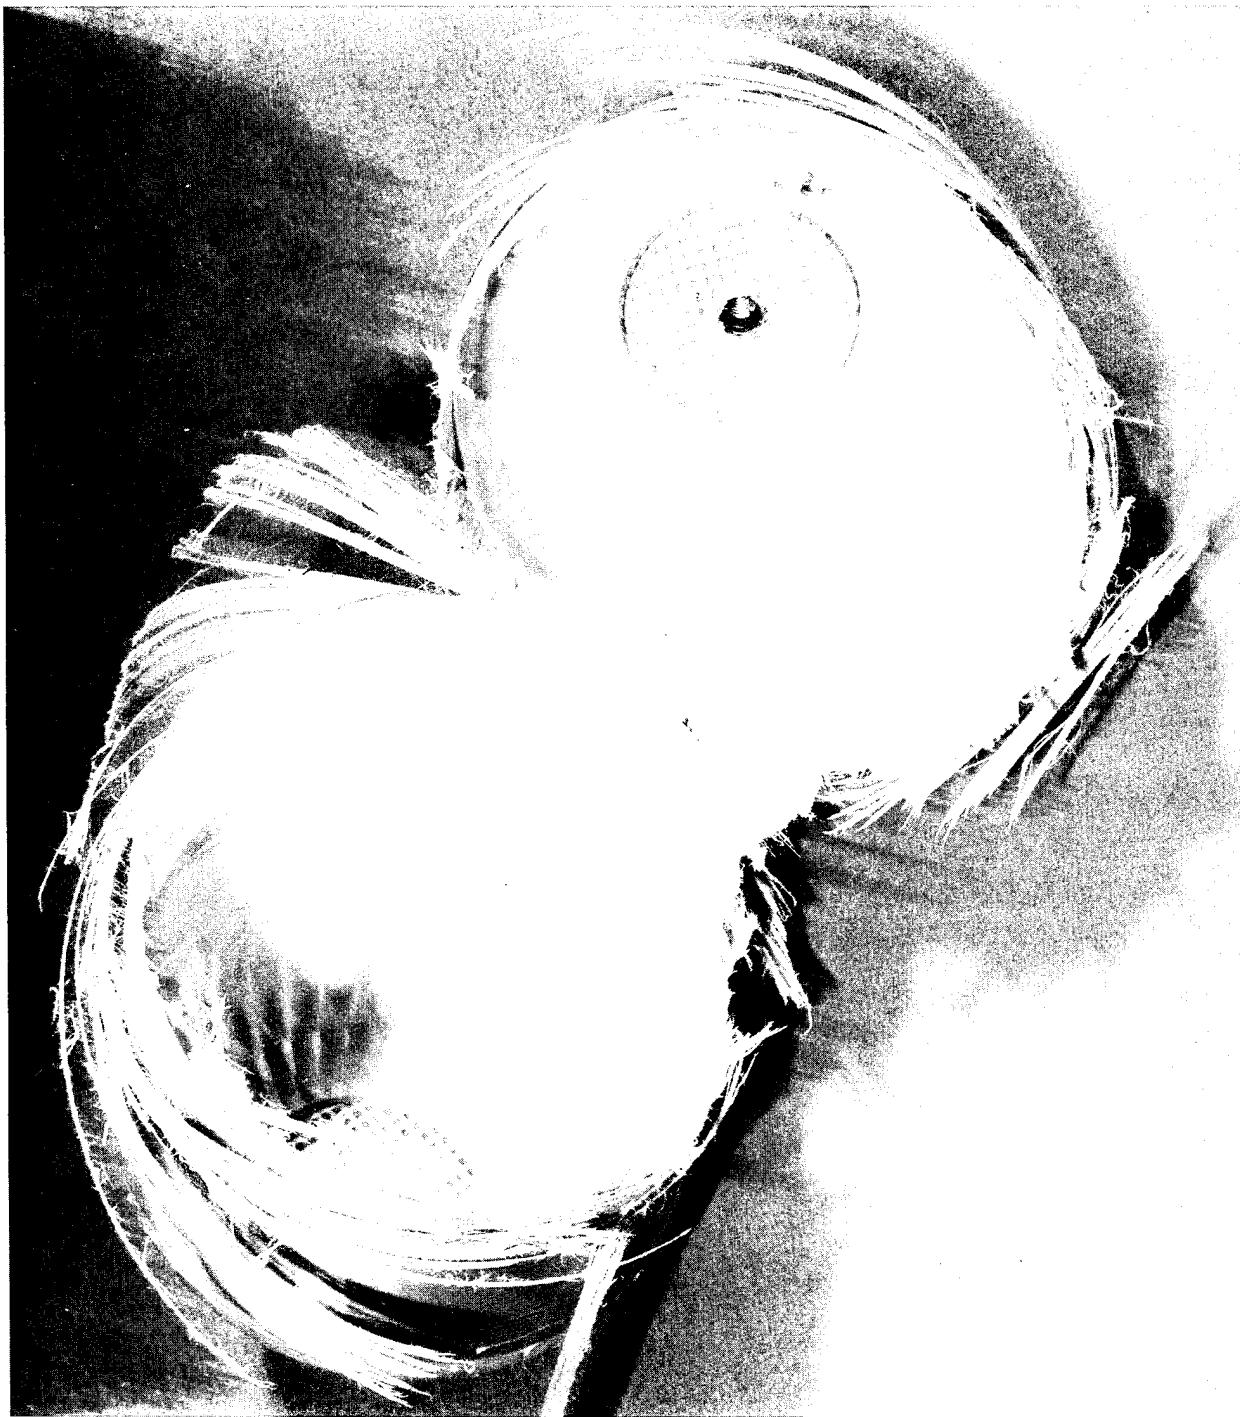
Fig. 44. Photograph of an ABS-lined pressure vessel wound with the double pattern overwind showing the hoop mode of failure (vessel failed at 36.8 MPa).
